Later Wood Frame Houses (1905-1930)

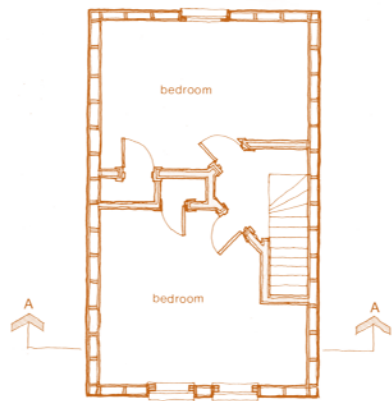
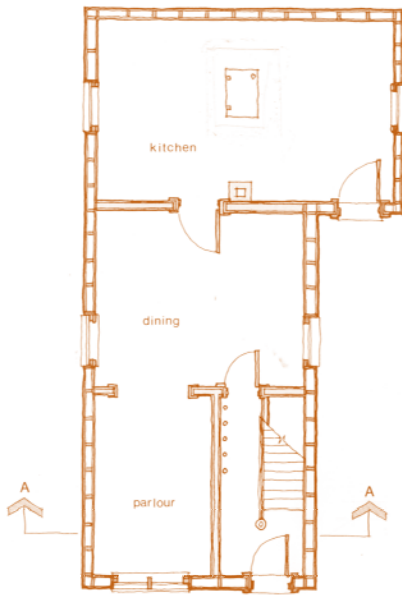
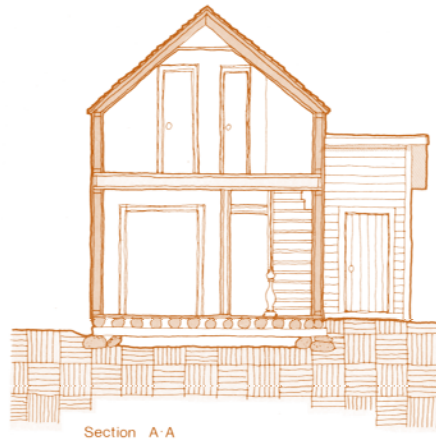
Figure 24
Five-roomed gable roofed house
with shed addition: floor plans and
cross section.

A typical example consisted of a five or six roomed, 1 1/2 storey gable roofed section, with a single storey shed at the rear. This shed portion invariably extended out about 1000 mm (3') to the right side of the gable portion, just enough to accommodate a front facing door. The main entrance of the building was usually located on the right front of the gable-roofed section. Floor plans varied only slightly in the remaining examples. The larger structures had three bedrooms in the upper level, while two bedrooms were more common in the smaller ones (Figures 24 and 25).

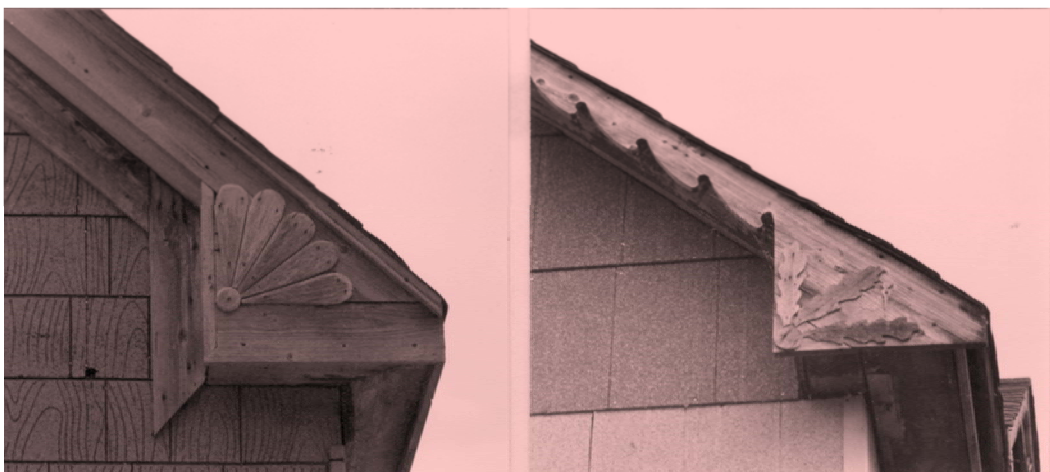
Figure 26

The sunburst pattern was the most common form of decorative trim found on the gable and shed eave returns. Alternatively several featured an oak leaf motif. In this instance the oak leaf motif is accompanied by a decorative bargeboard cut into the shape of cresting waves.

Most of the gable-and-shed residences remaining featured distinctive decorative trim on the gable ends and around the windows. Prominent eave returns were found on virtually all of the buildings; on most this was accompanied by decorative patterns (Figure 26). Decorative wood shingles above the windows on the gable ends were also fairly common, and a few examples with bargeboards were also found.

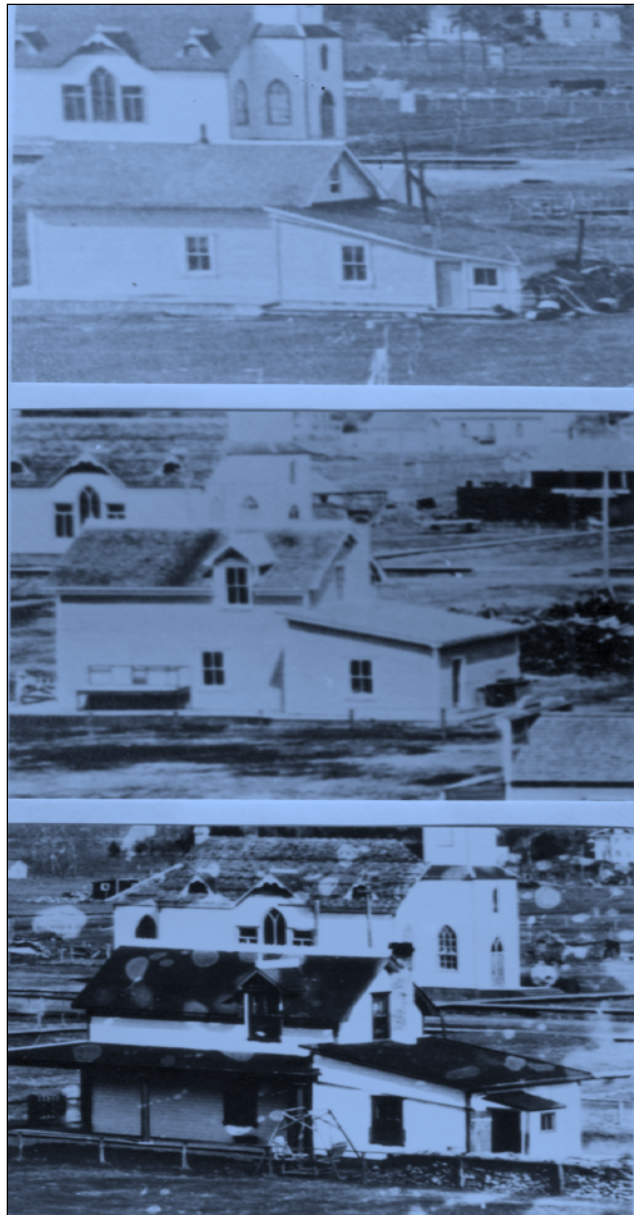
Figure 27

This series of early photographs of Gimli show the succession of changes made to a typical gable roofed house with a shed addition.

Like most early houses in the planning district, a number of changes or additions were often made over the years to the basic gable-and-shed form (Figure 27). The construction of a wraparound verandah was often accompanied by a second storey sun deck.
